Rising safety hazard related to hydrogen on-road applications as leave the laboratory environment

Henrik Domanovszky

Graduated engineer of transport Ms.C, Ph.D Candidate, LNG.hu Engineering Kft., Hungary

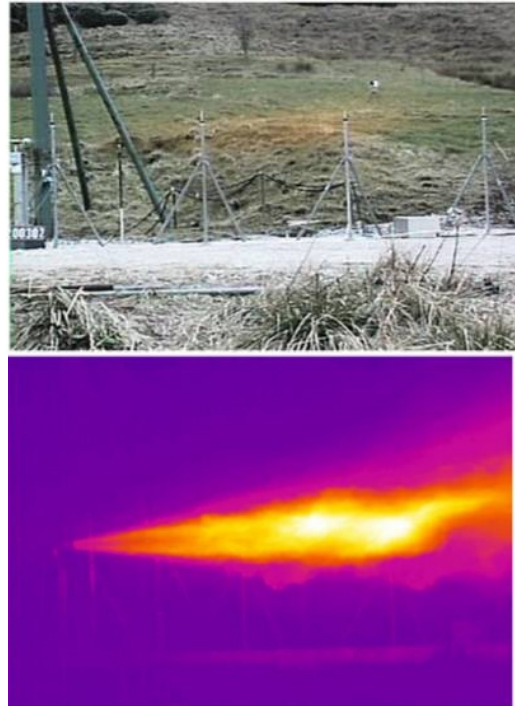
Fig.2.: Comparison between the visible flame (above) and the flame extent obtained through thermal imaging (under) (Moonis et al., 2010, taken from [8])

As second, the perfectly burning mixture has a high temperature of 2318 K, what is mostly invisible.

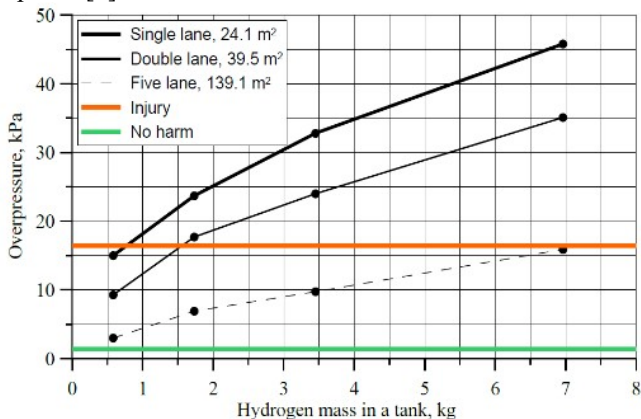
Fig.3.: Blast wave pressure in different tunnels 140 m away from the centre of the hydrogen detonation [9]

As effect of the tank filling rate and the quantity of the fuel inside the tank has relevance for the blast wave it can occur. Analysing the tunnel effect, the HyTunnel-CS project was concluded the following diagram, with a burst of a 700 bar tank at the previously examined 94.5 MPa pressure level. The lines are showing the recorded maximum blast wave overpressures at 140 m distance from the experimental tank rapture. [9]

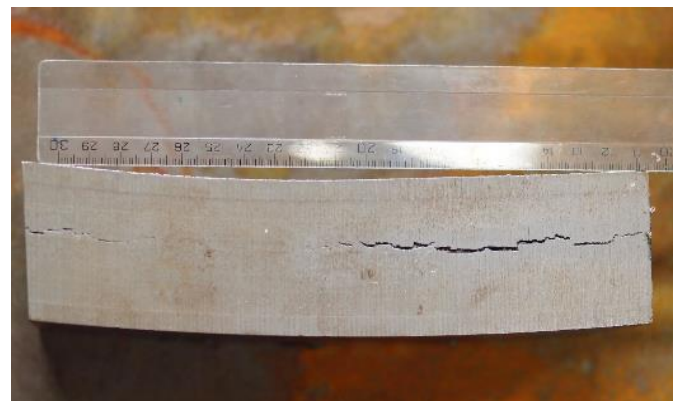
Fig.4.: This excised piece of a hydrogen industrial spherical container shows the hydrogen accumulation deep in the 50 mm wide steel plate, which was even able to straighten the inner side. Under heat and pressure the Hydrogen bubble created bursting force is over 100 MPa range. [Author]

In the metal the dissolved hydrogen atoms concentrates, creates gas bubbles (“blistering”), defecting the crystal structure, while the metal ductility decreases and becomes brittle. The concentration in the metal grain boundaries potentially forms hydrates and the hydrogen and metal reaction increase the embrittlement mechanism. The propagated internal cracks is the “hydrogen induced cracking”.

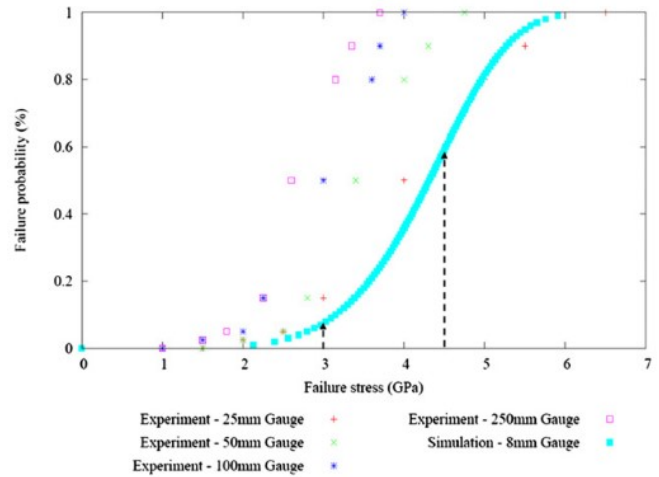
Fig.6.: Probability of failure curves for different length of carbon fibre samples and the consequence of overloading on number of broken fibres [16]

The carbon-fibre strength scatter is illustrated through the probability of failure curves.

The fibre failure curve has some important aspects according to the study [16]: *“The main strength of carbon fibres depends on their length, or more correctly their volume. The strength is not an intrinsic material property but is stochastic, reflecting the distribution of defects in the body....The arrows show the effects on number of fibre breaks of overloading by fifty percent. It should be obvious that the traditional hydraulic pressure test in which a pressure vessel is subjected to one and a half times the maximum in service pressure is far from ideal for evaluating the behaviour of a composite pressure vessel and results in further damage to the structure.”*

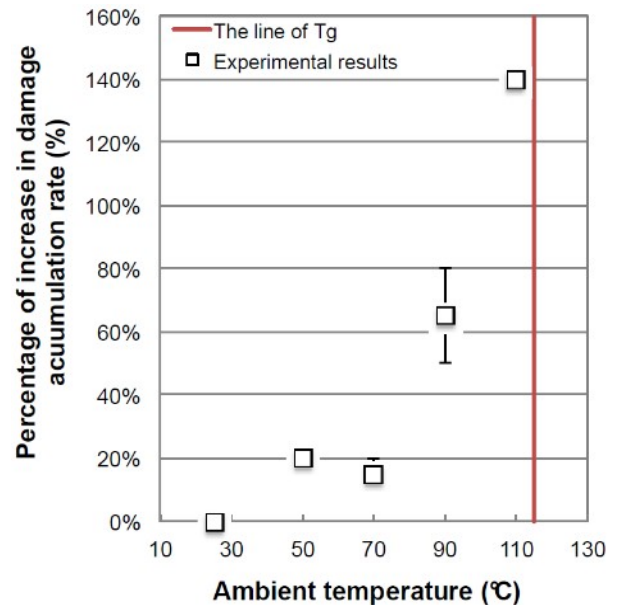
Fig.9.: “Percentage of increase in damage accumulation rate with respect to ambient level. The test were carried out in the sustained tensile loading at 50% of average failure stress.” [26]

When the level of ambient temperature was elevated, the molecules of epoxy matrix became active due to the absorption of heat energy and the epoxy polymer (glass state) transformed toward rubbery state. As a result, the creep process is the epoxy matrix was augmented in the composite. This means that the efficiency of load transfer mechanism at the interface of fibre and matrix declined and the effect of the existing fibre breakage in the neighbouring fibres enlarged. Consequently, more neighbouring weak fibres were likely to rupture. The (next graph) shows that the elevation of the temperature accelerated the growth rate of fibre breakage; the increase in damage accumulation rate was increasing at a rapid rate with the elevation of the temperature toward T_g .

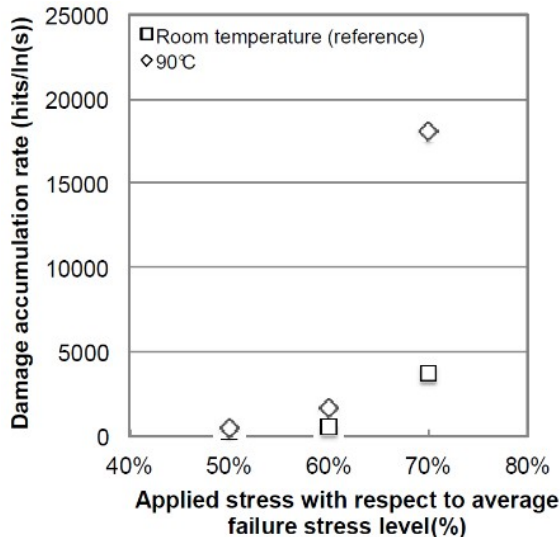
Fig.10.: "Damage accumulation rate measured for the UD specimens subjected to sustained tensile loading test under two-stage temperature conditions: room temperature and 90°C. The applied stress levels were varied from 50%, 60%, and 70% of the average failure stress level." [26]

Moreover, the effect of elevated temperature was severe when the composites were subjected to higher level of the applied tensile load. The (next graph) shows that the increase in damage accumulation rate was higher for the UD specimen (carbon-epoxy probe) tested in the 90°C environment when subjected to higher applied stress level.

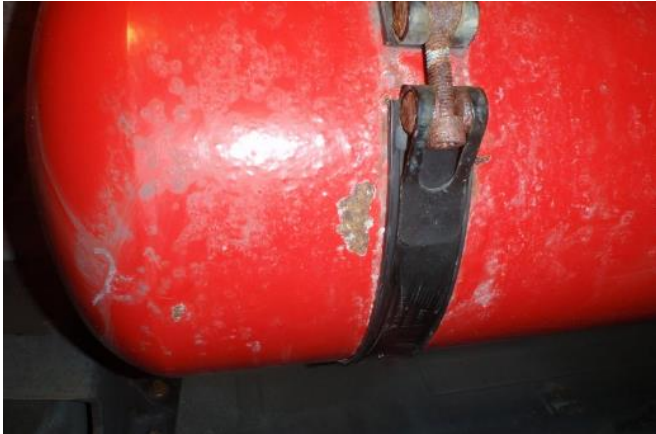
Fig.11.: At the inspection as “not usable” determined Type 1 cylinder under a CNG vehicle, because of the material corrosion. This type of failure can be detected well, if the vehicle inspection is regular and serious. In 2017 there was a wave to recall most of the VW CNG vehicles to check their bottles and had been replaced a large number of them.
[Author]

The condition of the painted steel can be easily analysed and recognize if any injury on corrosion protection or corrosion started to reduce the material stiffness. As it was a serious issue at the earlier vehicle types, some corrosion resulted by the not reliable protection of the vessels which were mounted under the vehicles exposed to the harsh

environment of every days use. That can be detected at the regular inspection and if problem founds, the change of the vessels can be prescribed.

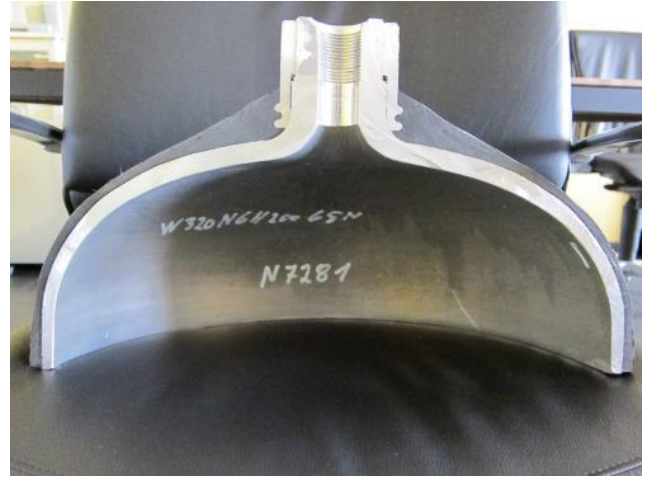
Fig.12.: Type 3 vessel cross section at the neck part
[photo: Dynatek]

The Type 3 version is intend to be a far lighter container as the Type 1. The stiffness of the structure primarily can be weakened by any means of injury on the wrapping. Any surface scratches that deeper as 1.5 mm should not be considered to operable any more. It need to send back to the producer for analysis and repair, if that found as possible. Nevertheless, the test procedure of the type approval require a sequential pressure test for tube, which one scratched over the limit. This is a so tiny surface damage that not easy to recognize, and can be traced back for any mishandling action. Widely understood that based on the wrapping liner quantity, the Type 3 cylinders can be made to allow way higher pressure ranges as the CNG would require.

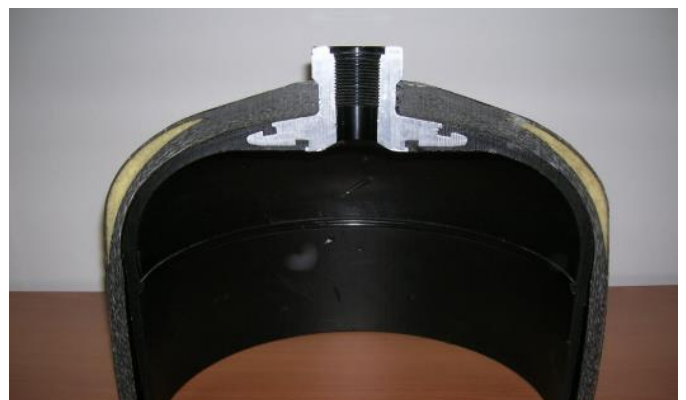
Fig.13.: Type 4 vessel cross section at the neck part

- Type 4 – it is also composite with carbon fibre or fiberglass full wrapping, but the inner shell layer (called it liner) is made from non-metallic material, means plastic, High Density Polyethylene (HDPE). The Type 4 is sometimes referred as all-composite cylinder. Where the end Boss part is made from metal to make available the joining with the fitting parts.

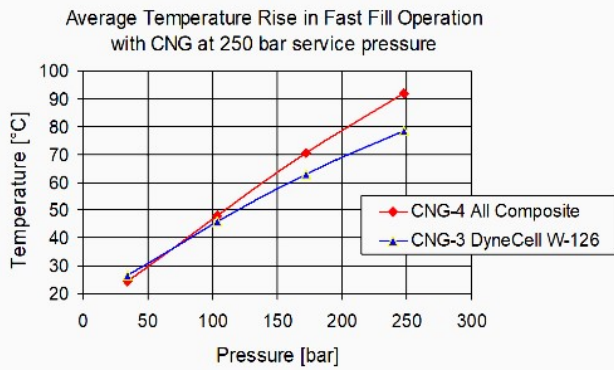
Fig.17.: Temperature comparison of Type 3 and Type 4 CNG cylinders during fast fill to 250 bar storage service pressure [20]

During the fast filling, the gas temperature increases rapidly, as it is visible on the graphic. A temperature measure analysis [20] compared two different composite tank design (both are 350 mm diameter, 200 bar NWP). The polymer tank liner has low heat absorption (thermal conductivity=0.36 W/m²K), resulting 68°C gas temperature increase, 16°C more as the Type 3 version equipped by aluminium liner (thermal conductivity=204 W/m²K). The different is resulting 11 % longer filling time. Moreover, as the gas cools down in the cylinder and reach the stabilized temperature (in this case the initial 25°C), the pressure different remain remarkable: 213 bar compare to 203 bar, so the range of the vehicle, which is almost 5 %.

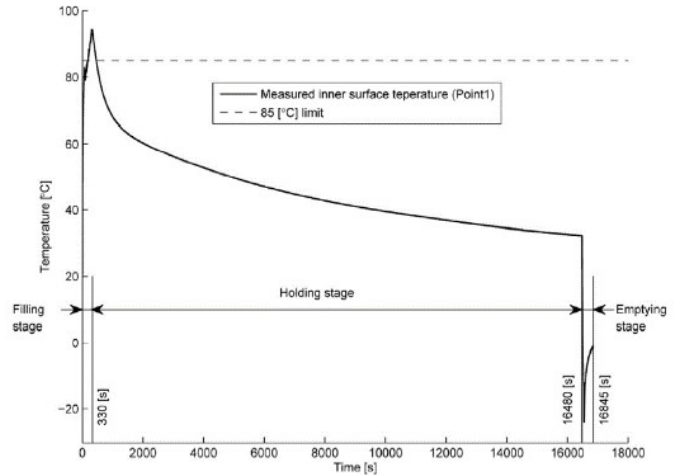
Fig.19.: The measured temperature on the liner’s surface was rapidly increased during the filling, up to 93.95°C, while the rapid emptying – took 365 s – lead to a rapid surface cool down [22]

The analysis experienced temperature data from two different sized Type 4 and one Type 3 vessels. Altogether 165 different measuring cycles have been performed, includes different average filling speeds, the so-called Average Pressure Ramp Rates (APRR). Some statistically averaged data from one of the Type 4 tank measurements, without APRR modification, as an illustration: There took 253 seconds to reach the final pressure from the initial (up from 1.99 to 76.89 MPa), the bottle inner surface temperature increased from 11.2°C to 86.9°C. Remarkably:

“after emptying, however, stratification in gas temperature is significant and a difference of 27°C from bottom to top of the tank is observed” [21].

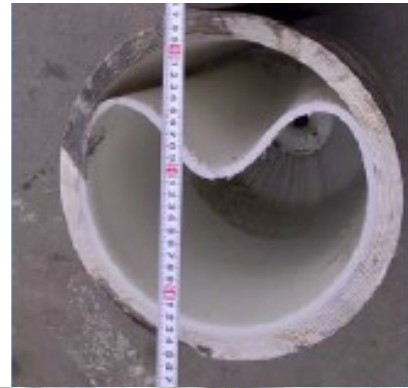
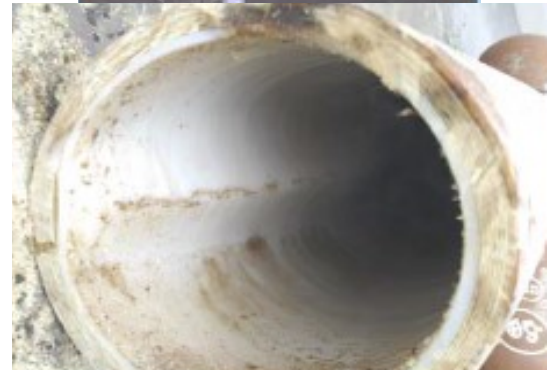
Fig.22.: The blistered liner can see on the above cut up cylinder, at low pressure the strung-out liner come off the epoxy-fibre layer, and the hydrogen accumulating between. On the lower picture the one already cracked liner is visible. The increase of the hydrogen passage through the wrapping resulted. [Source of the photo is uncertain]

As it is shown at the previous chapter, the temperature of the bottle is changing cyclically during and after the filling of the vessels. This phenomenon is reflecting also to the filling technology. Beside of the temperature, it is also obvious that the buffers are dilating, like breathing. At this point, the all composite has an extremely bad cooperation behaviour between the liner and the outer enforcement wrapping structure. Unlike to the reinforced concrete structures – where the long-life of the structures are based on the equal expansion coefficient of the iron and concrete – here the liner is not only warming up far more, but the expansion coefficient is widely different to the wrapping. This gives for the liner an independent live and if the inner pressure gets low, the liner can reshape.

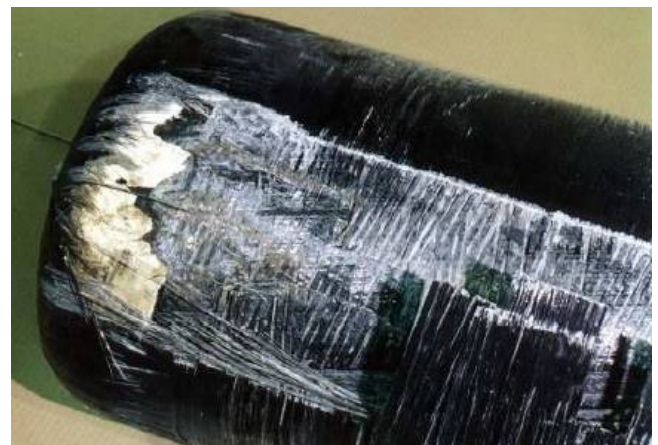
Fig.23.: Bus tank after impacted with an over-bridge [28] Cannot miss from this list, the cylinder's improper treatments, like an event as falling. That can occur an external abrasion, or damaging on the surface of the wrapping by sharp, abrasive tools and through effecting the fibre-epoxy structure.

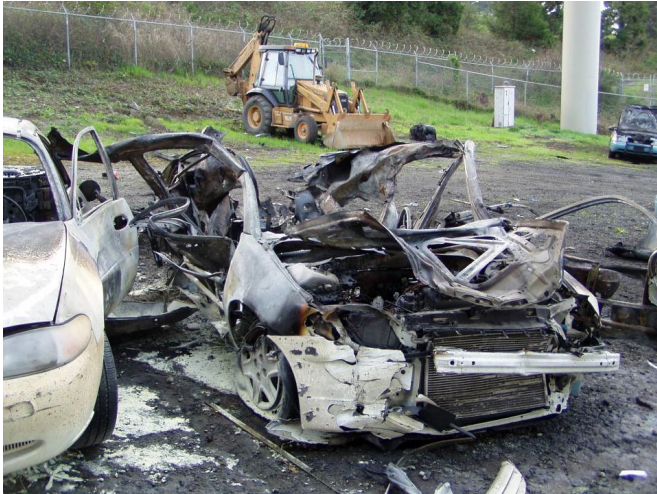
Fig.24.: The case of a CNG propelled Civic in 2007 in Seattle, where the PRD was not opening and actuating releasing the gas. The ruptured tank was landed beside of the excavator [Photo 23, 27]

“at least two CNG cylinder rupture reported due to fire exposures that did not cause PRD actuation”.

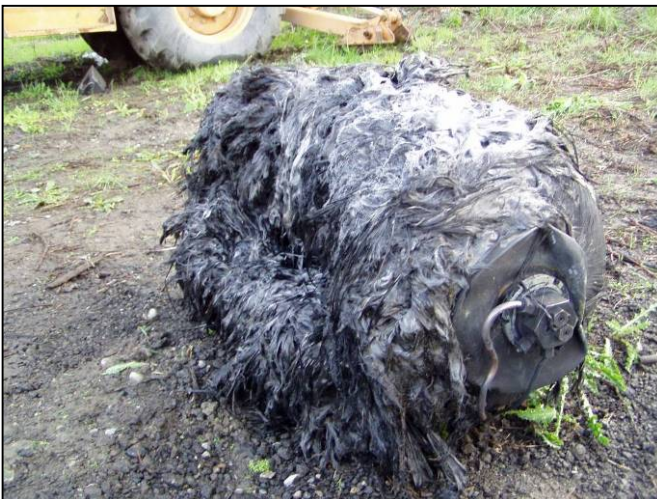
Fig.25.: The bursted and burned cylinder residuum from the Civic [27]

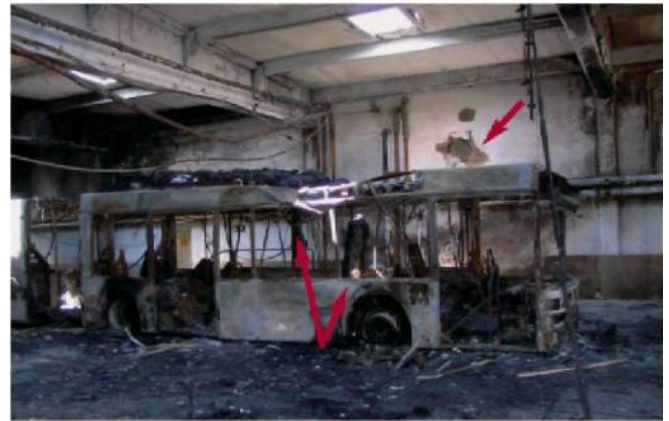
Fig.26.: The above arrow shows where the wall was leaked through by the exploded tank [24]

staying besides, each equipped ten roof mounted, doubled TPRD protected Type 3 CNG vessels. One of the busses got fire from the engine compartment and in the fire, one after the other tanks released their gas content as it is design to do so. The released gas burnt in the depot and the fire propagated from the back of the bus to another one, which were parked at 1.5 meter behind. *“19 of the 20 CNG tanks exposed to the fire did behave as expected.”* Unfortunately, one TPRD was not releasing and about 15 minutes after the fire started, that tank burst. *“A large fragment was propelled in the tank axial direction. It broke through a nearby wall (hole at 3 meters from ground level) flew through the air and damaged another wall located 25 meters further and ended up it’s journey on the roof of a bus parked in a nearby depot.”* [24]

There were some well reported conclusions on the German case. First, the tanks were mounted with two TPRDs on both of the ends of the tank, while just front of the tank a top roof was open, let the fire come out from the passenger compartment and directly heated the tank’s middle section. The flames were not heat the TPRDs fast enough, while the middle section was experience a heat stress. *“This remark underlines that tank fire protection and bus fire safety can not rely only on the performance of isolated protected tank systems.”* [24]

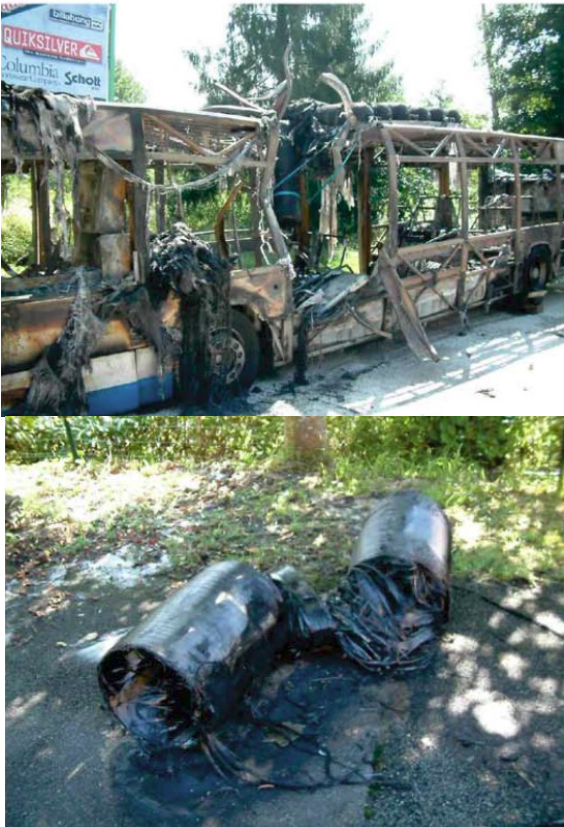
Fig.27.: The burned out bus in Montbéliard, and the residue of the cylinder, which splitted in two parts. The initial problem came from the electrical circle of the bus [24]

At the Montbéliard accident (2005) the Authors could declare: the TPRD connected to Type 4 tank had not sufficient gas through put, to fulfil the French regulation and the pressure reduction couldn’t be fast enough. The fire initially was a battery fire which propagated throughout the complete bus. Just 3 months later in the same year, a same type of bus in Bordeaux have been burned out, because of vandals threw a Molotov cocktail inside the bus and the first cylinder exploded again.

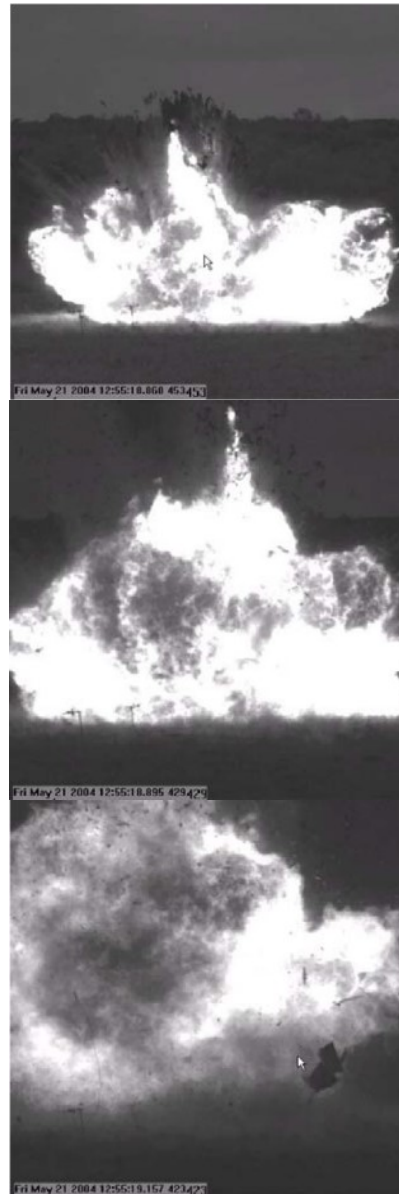
Fig.28.: Fireball captured by IR camera, from above, 10 msec, 45 msec, 107 msec after the rupture [25]

Mr. Zalosh and Mr. Weyandt with the Motor Vehicle Fire Research Institute made a fire test [25] with hydrogen filling on a Type 4 tank and a Type 3 tank, built into an SUV, to see, if that works similarly to the CNG cases. With propane burner under the tank reached the tank ruptures at both of the cases. Instead of releasing the gas, the Type 4 tank within 6 min 28 sec, the Type 3 tank within 12 min 18 sec. At both of the cases, the composite wrapping layers were preventing the hydrogen to warm up and rise the pressure significantly above their settled release value. The occurred blast wave pressures were calculated to be as high as 13 MJ and 15 MJ. Vehicle parts found over 100 m away. Resulted hydrogen fireballs detected with a maximum diameter of 7.7 m immediately after the rupture. *“The results of these tests suggest that the danger zone associated with hydrogen cylinder rupture extends to a radius of roughly 100 m from the hydrogen vehicle.”* [23]

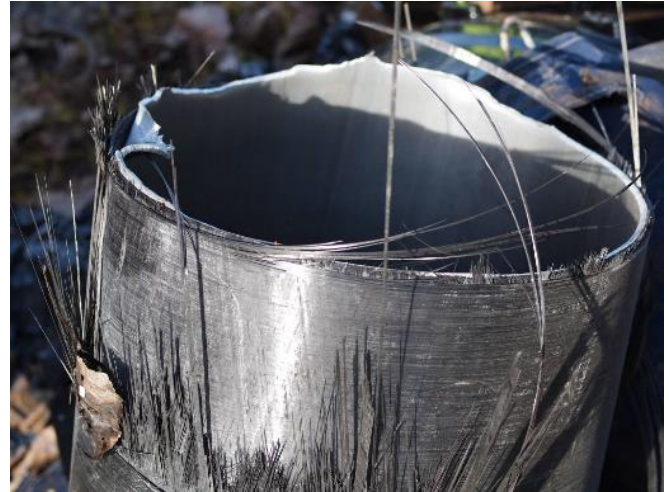
Fig.30.: The carbon fibre wrapping was capitulating way under the design pressure. In the middle, the metal liner material flown. [Author]

As finished the “tuning”, opened the valves and found that everything works properly. Drove to the CNG station and without any notice about the modification to the employee, let the vehicle fill. However, the station employee at a certain point recognized that the normally filling quantity exceeded and let the filling continue. Somewhere around 100 bar one tank was ruptured into two parts. The blast wave was speed up the part of the tank to tore off the vehicle’s sliding door, flying into a parking urban bus’s window, about 6 meters away. Attacked the handrail, from where changed the direction and flew out through the front window. Another part of the tank simply trampled to the ground a fuel dispenser. The employee seriously injured. The gas was not ignited, and no flame occurred, because of natural gas. In the presence of Hydrogen that for sure would happen.

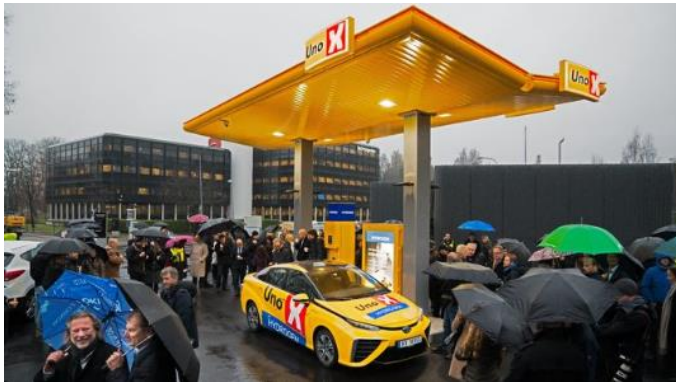
Fig.36.: The incriminated station proper design includes fire and pressure protecting wall around the equipment room [photo: Eirik Helland Urke]

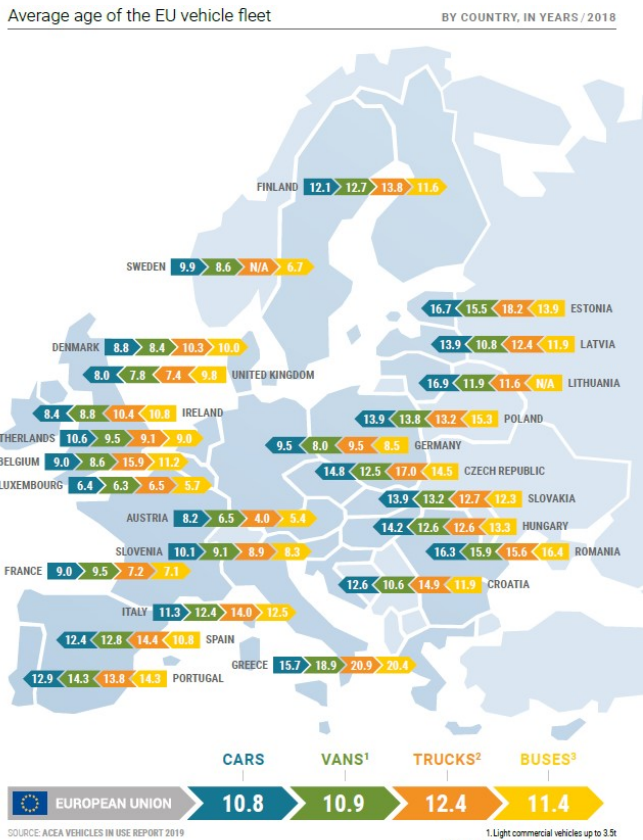
Fig.44.: The average age of the vehiclestock in the EU without Bulgaria, Cyprus and Malta is 10.8 years, reported in 2019 [37]. Can not be missed the significantly different figures along the two sides of the former ironcurtain

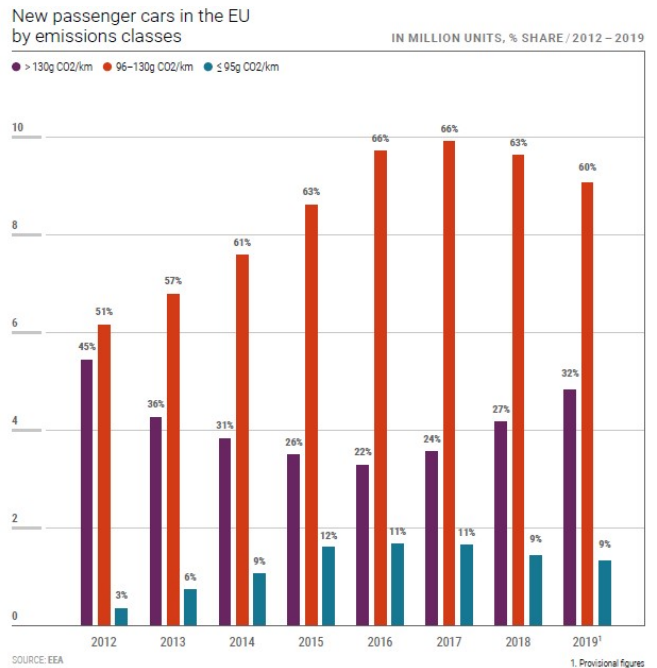
Fig.47.: It should be a clear answer how the new vehicle buyers are seeing the CO₂ reduction. Between 2016 and 2019 the share of >130 gCO₂/km passenger cars grown from 22 % to 32 %, while the overall sales went up by 4.9% in this period [37]

The changing taste of the Customers resulted: since 2016, the CO₂ figures moved in the opposite direction as it was ordered

by the regulations of the European Commission and the Parliament. The share of the less than 95 g/km vehicles went down. The share of the 96-130 g/km vehicles went down. The share of the larger than 130 g/km vehicles went up. All of this happened besides of the continuity of the technical improvements. It is a clear sign from the new vehicle customer preferences. The Voter’s answer for such a question, which never been politically raised for the Citizens to answer it, but continuously governed without their democratic delegation.

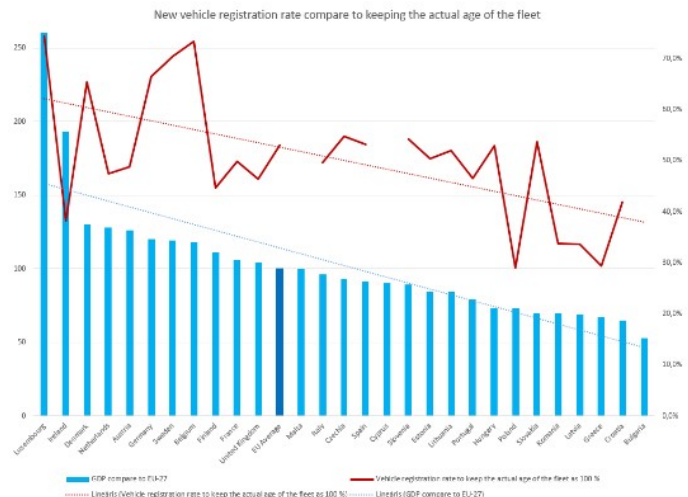
Fig.50.: The new vehicle registration numbers in 2019 in none of the Member States are supporting to keep the average age of the rolling stock. Even in Luxemburg registered only 75 % of that vehicle quantity, which could keep the age-level. At the low end, the figure is under 40 % of that new registration, which would keep the age of the very old vehicle park [Author]

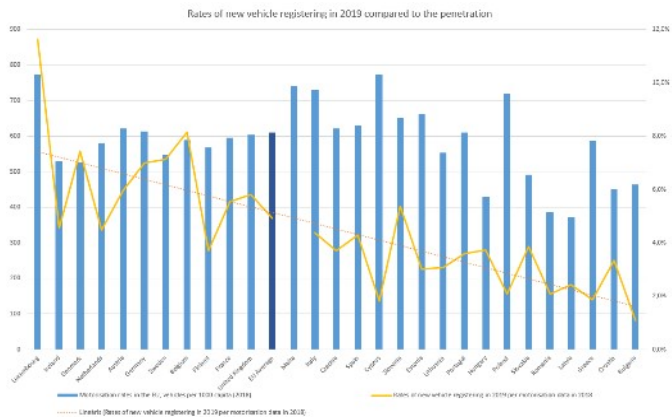
Fig.48.: There is a 10-fold different between Luxemburg and Bulgaria in the new vehicle registering per circulating vehicle numbers. The relation between GDP and the speed of fleet refreshing is not even close to show a parallel trend line [Author]

western to the eastern countries – the GDP dependent correlations exist in the numbers. There is a wide different between refreshing the existing vehicle park by 11.6 % new vehicles in one Member State comparing to another State, where it is less than 1.1 %. Furthermore, 67 % more vehicles per capita existing in the first as in the last here mentioned country. There is no need for further argumentation: not possible to keep forcing the same regulatory measures.

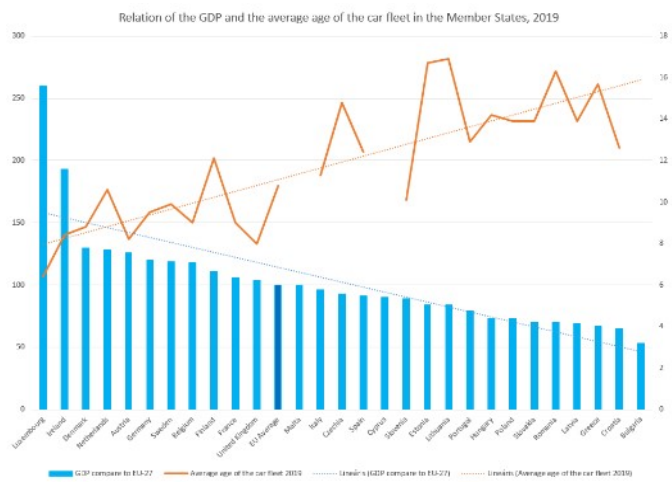
Fig.49.: Obvious inverse relationship can be found between the GDP and the average age of the vehicle fleet across the Member States. Data for Malta, Cyprus and Bulgaria not released by ACEA [Author]
